**Wilson Downing Tributary to West Hickman Creek (WH-2)  
Floodplain Analysis**

**Prepared for:  
Lexington Fayette Urban County Government**

**Prepared By:  
Integrated Engineering  
166 Prosperous Place, Suite 220  
Lexington, KY  
40509**

**Date:  
September 1st, 2014**

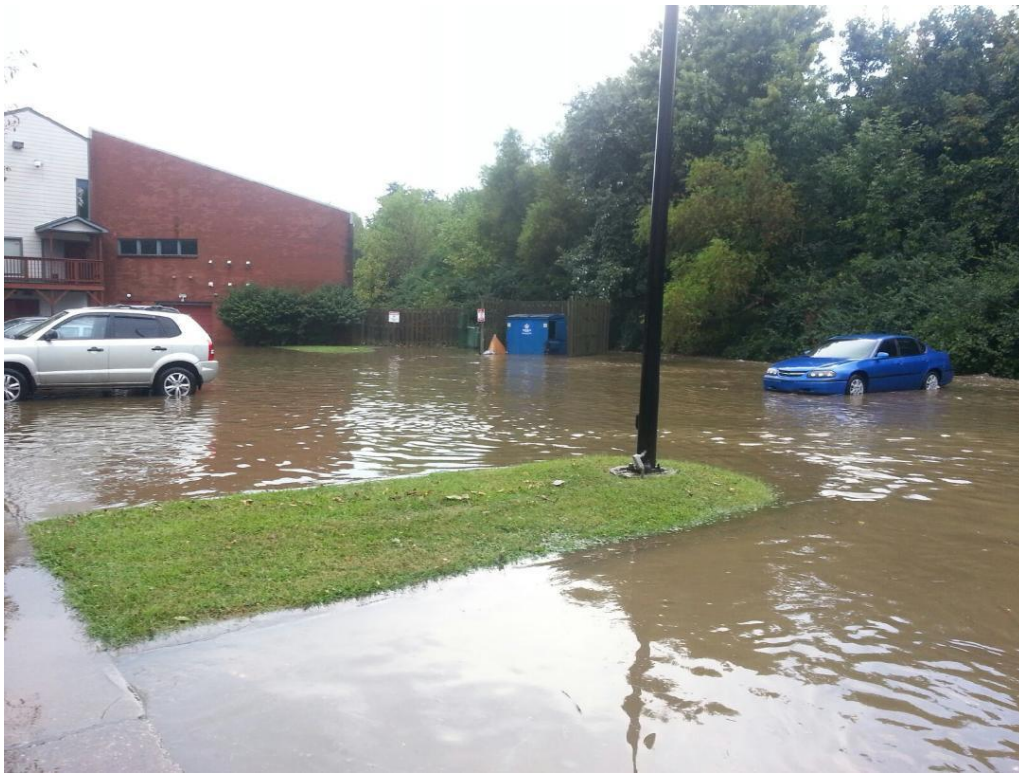
As previously mentioned, the high water mark between river stations 4441 and 4639 was reported to have occurred on August 31<sup>st</sup>, 2013. This was the only high water mark that could be tied to a specific documented rainfall event. The water surface elevation for this rainfall event was reported to reach the doors of the cars in the parking lot of the Downing Place Townhomes. The picture below was taken after the water had receded slightly from the crest.

**August 31, 2013 Flooding Event  
Downing Place Townhomes  
(Between RS 4441 and 4639)**

The crest elevation for this event is estimated to be approximately 925.75 feet. Rainfall records were obtained for this storm from the East Hickman Gage. This gage is located on East Hickman Creek in

southern Fayette County as shown in the map below. This gage is located approximately 2.7 miles south of the confluence of Wilson Downing Tributary and West Hickman Creek. The rain gage data was entered into the HEC-HMS model and the resulting flows entered into the HEC-RAS model. The resulting water surface elevation from the HEC-RAS model for this storm is 926.03, which equates well with the high water mark elevation of 925.75 feet.
